AEROPRAKT NOTIFICATION

No. N A32-17

HOLES IN THE FLAPERON HINGE AXLES IN A32 AND A32L AIRCRAFT

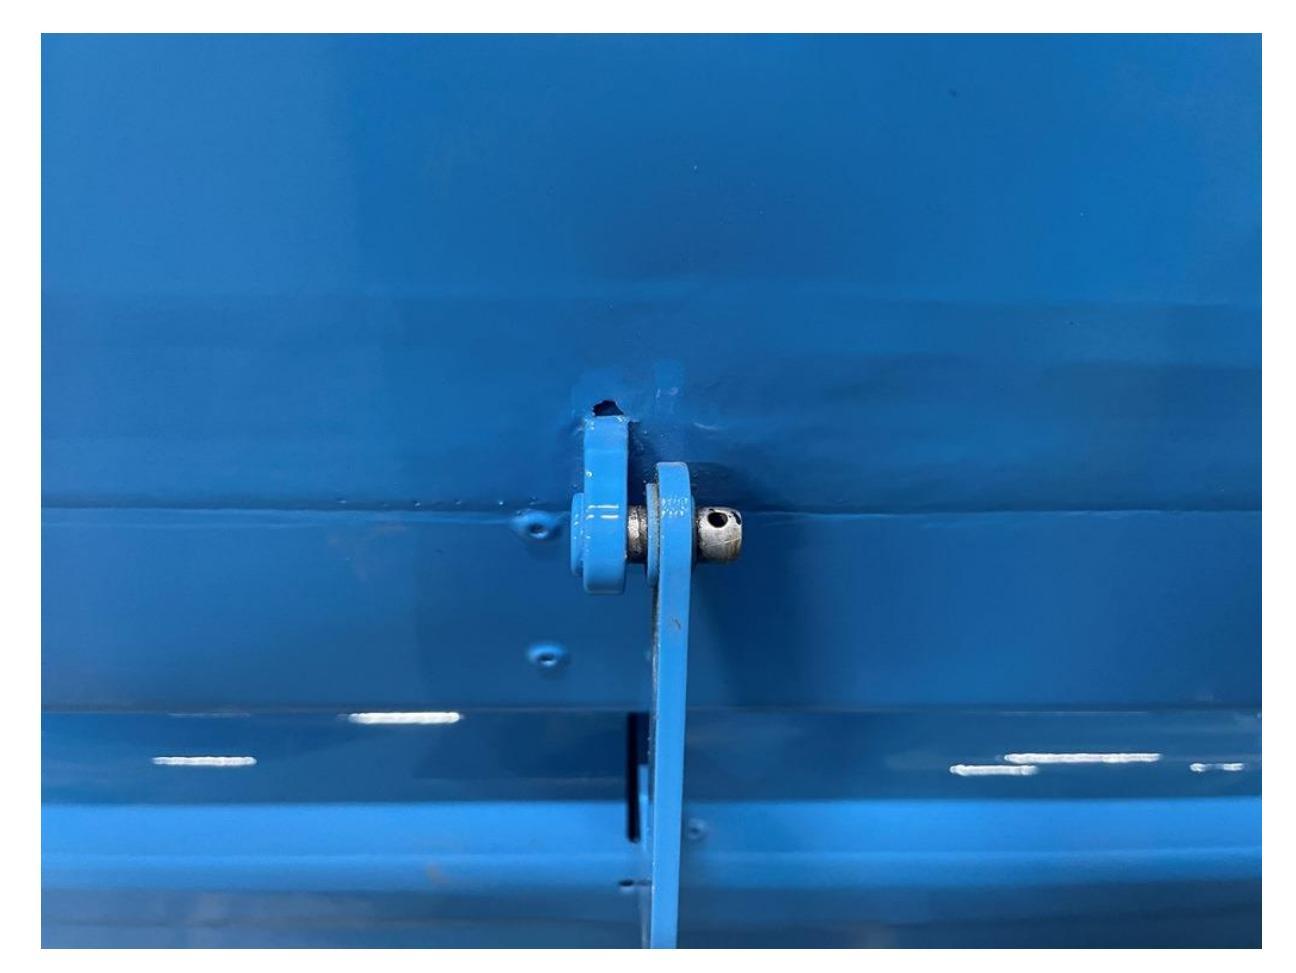
- Do not put any safety pins or wire in the holes in the flaperon hinge axles (see the photo below). It is a type-certified design. Failure to follow this instruction will invalidate compliance of your aircraft to the type design and type certificate.
- These holes are not intended for any safety pins or wire in the flaperon hinge axles. They are present because the flaperon hinge axles are made of a standard part (a pin with a hole for the safety pin/wire) the hole in which may be necessary for locking or safety pin/wire in other aircraft components. These holes in the flaperon hinge axles do not affect in any way or degree the normal function of the hinges.

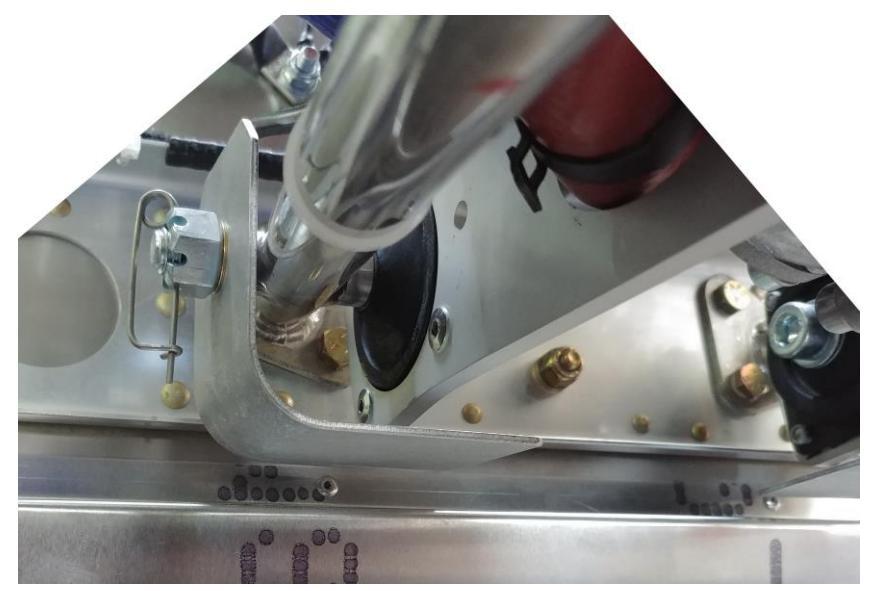
Intensive wear of the rear rubber shock absorbers of the engine mount due to the heat from the exhaust system elements.

- ▲ Failure to accomplish this work may cause complete disintegration of the rear rubber shock absorbers of the engine mount in flight.
- 3.1) Remove the upper and lower engine cowlings.
- 3.2) Remove the exhaust system without removing the exhaust gas temperature sensors from the exhaust pipes (if any).
- 3.3) Inspect the rear rubber shock absorbers for cracks and replace if necessary. Contact your local dealer on all issues regarding this replacement.
- 3.4) Install the heat screens on the left and right side as shown in Photo 1 for the right side and Photo 2 for the left side. The tightening torque of the M10 nuts is 20-25 Nm.
- 3.5) Re-install the exhaust system. The tightening torque of the M8 nuts is 15 Nm.
- 3.6) Re-install the upper and lower engine cowlings.

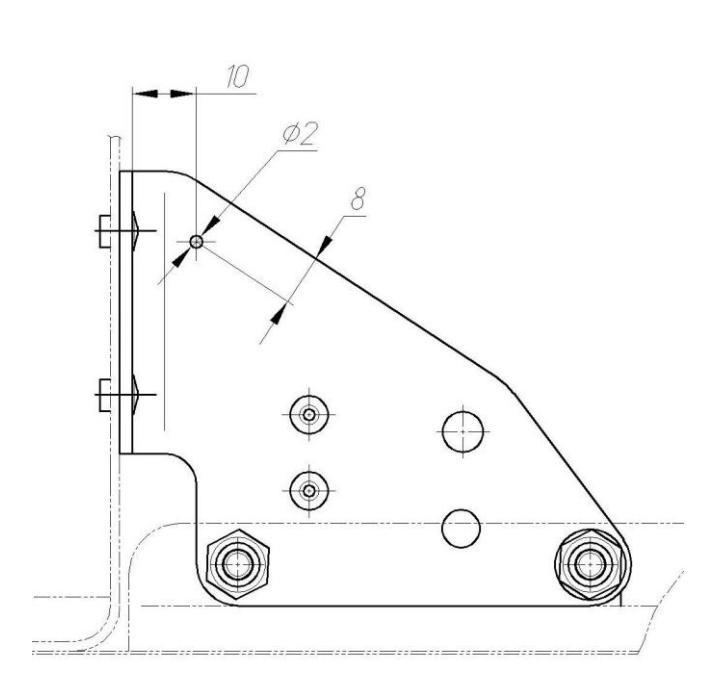
Fig. 4

It was found out that there was a certain deviation in shape of some parts of the roll control system. The tightening torque of the bolts attaching the control sectors affect their free movement.

- 3.3.1 Drill Ø2mm holes for safety wire (see fig. 4) on both sides of the additional supports of the control sectors. Remove the chips.
- 3.3.2 Fix the control cables on the new control sectors (No. 1R and 1L) using the cleats as shown on fig. 5. (right-hand shown, left-hand mirror view).
- 3.3.3 Install the control sectors (No. 1R and 1L) in their place (see fig. 3 and fig. 6). During the installation the cable guards must keep the control cables in the groves of the respective control sectors.
- 3.3.4 Fix the control sectors with AN4-17A bolts (No. 2) and tighten the bolts with 10 N \cdot m (7.4 lb ft) torque.
- 3.3.5 Connect the cables to the cardan using the "P" pins (see fig. 6). Lock the pins with split pins.
- 3.3.6 Lock the bolts No. 2 with safety wire through the holes in their heads and Ø2mm holes in the additional supports of the control sectors (see fig. 3 and fig. 6).

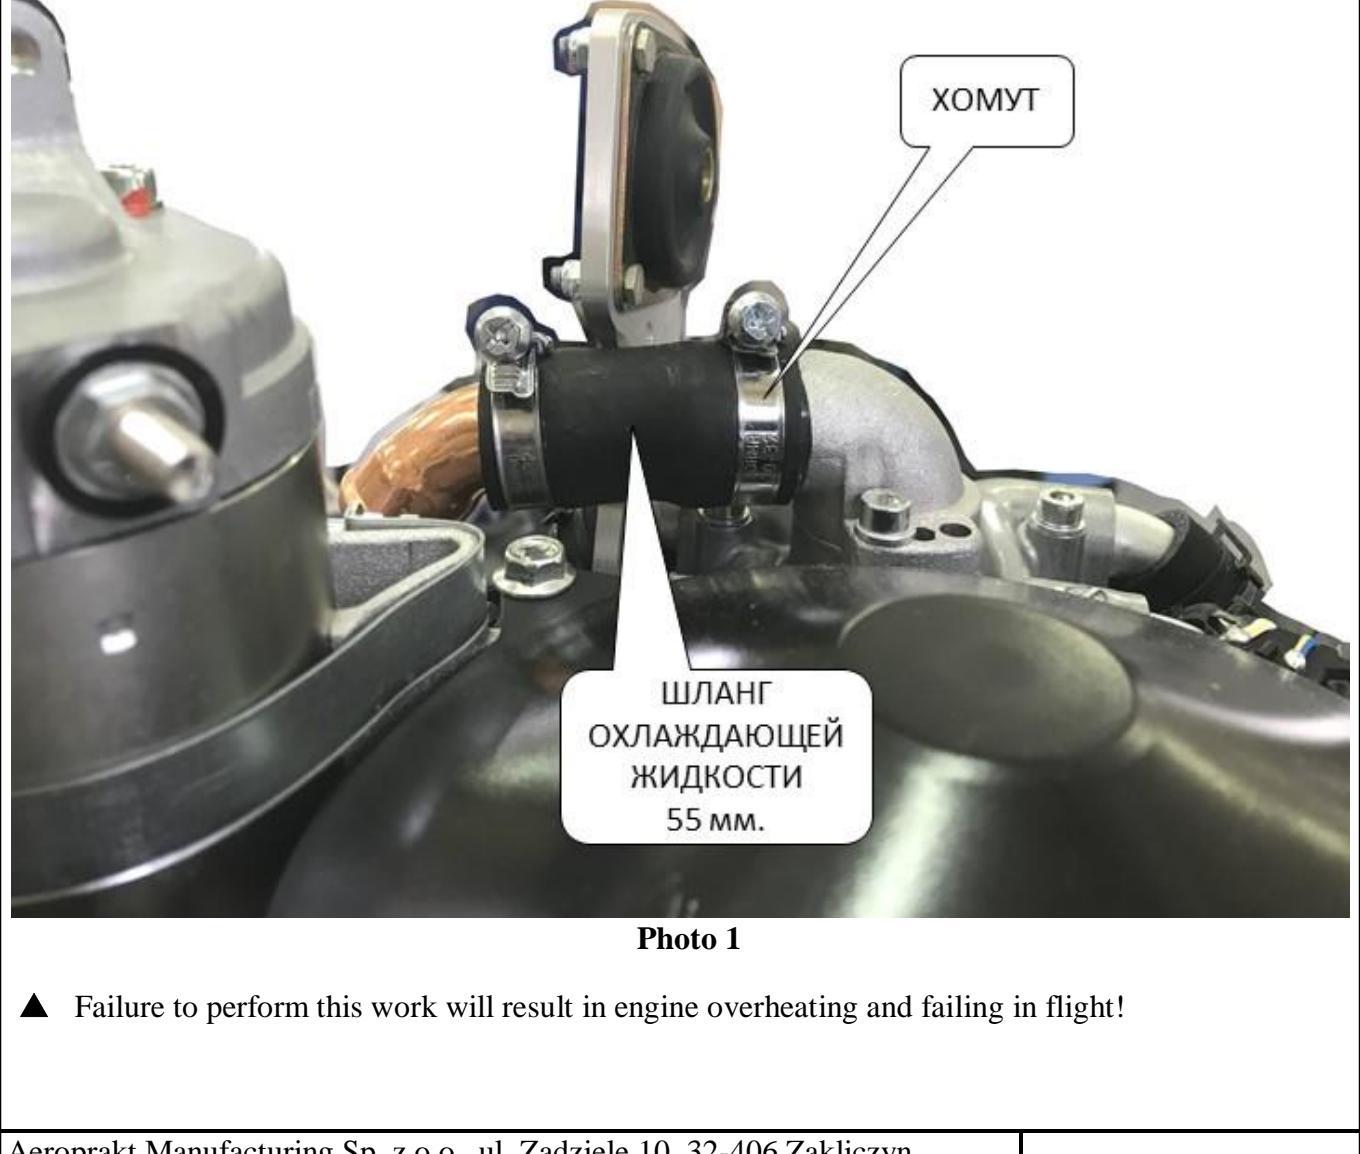
Cases of spontaneous disconnection of the coolant supply hose from the inlet pipe of the water pump (see Photo 1).

Screw-clamp attaching the water hose on the engine cooling system water pump inlet. See photo 1.

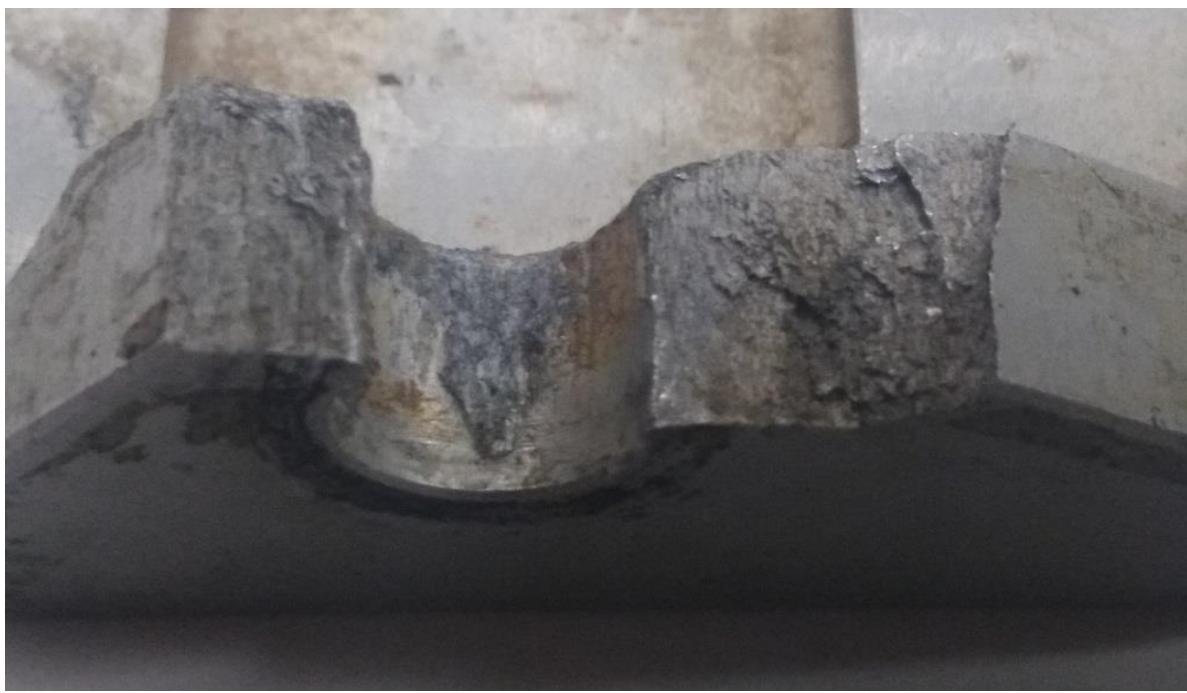
Photo 1

In conditions of high humidity and insufficient lubrication of the inner surface of the bracket hole (see photo 1) in the area of contact with the steel bolt, intergranular corrosion may appear, which affects significantly the bracket strength and may cause its disintegration.

If case if the intergranular corrosion is detected in the bracket, stop operation of the aircraft until replacement of the bracket. If there is no corrosion, continue to operate the aircraft with the bracket available, checking it for corrosion at every 100-hour inspection.
